# Implant explantation poorly positioned in an aesthetic sector and subsequent regeneration with block grafting. Clinical case

### Anitua, E

Published in spanish *Científica Dental* Vol. 20. Nº 2. 2023  
[www.cientificadental.es](http://www.cientificadental.es)

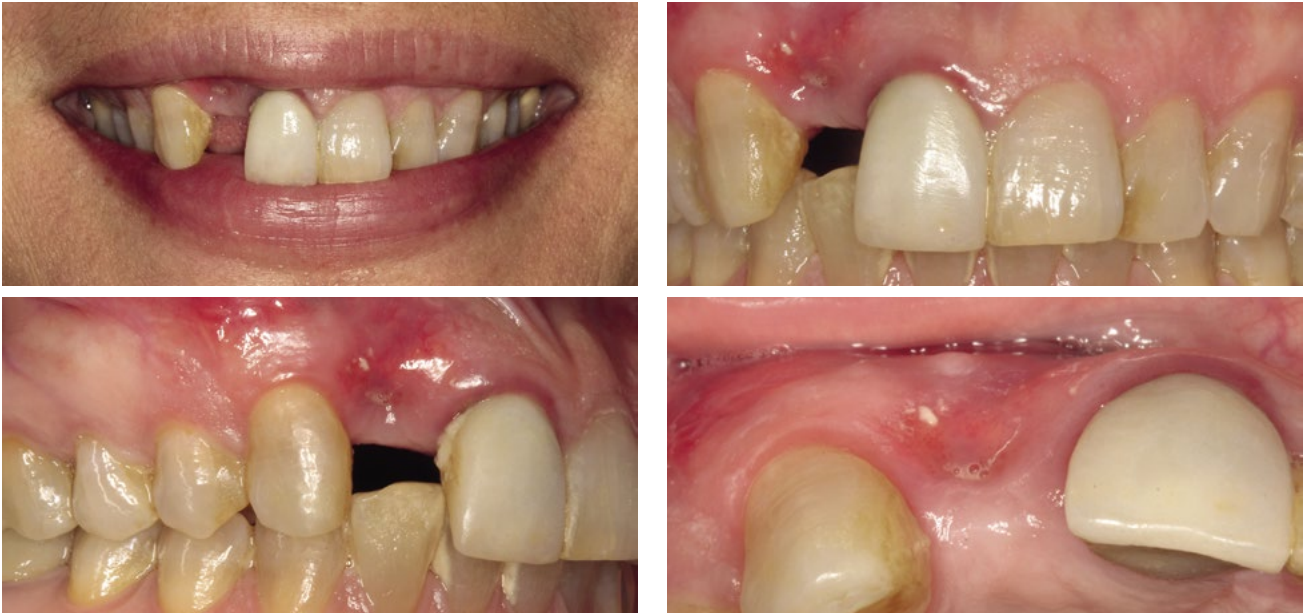
Figures 1-4. Appearance of the soft tissue of the implant area generating the problem, with loss of gingival thickness and an evident fistula.

We present the case of a 36-year-old woman who comes to the clinic demanding solution for an implant located in position 1.2. This implant has carried a rehabilitation with a crown for a short period of time in which an important mucositis and loss of the thickness of the gingival tissue occurred, for which the crown was removed. The patient has a provisional removable crown and the soft tissue surrounding the area of the initial emergency of the implant-supported prosthesis is in bad condition, with a significant loss of thickness and the remains of a soft tissue fistula (Figures 1-4).

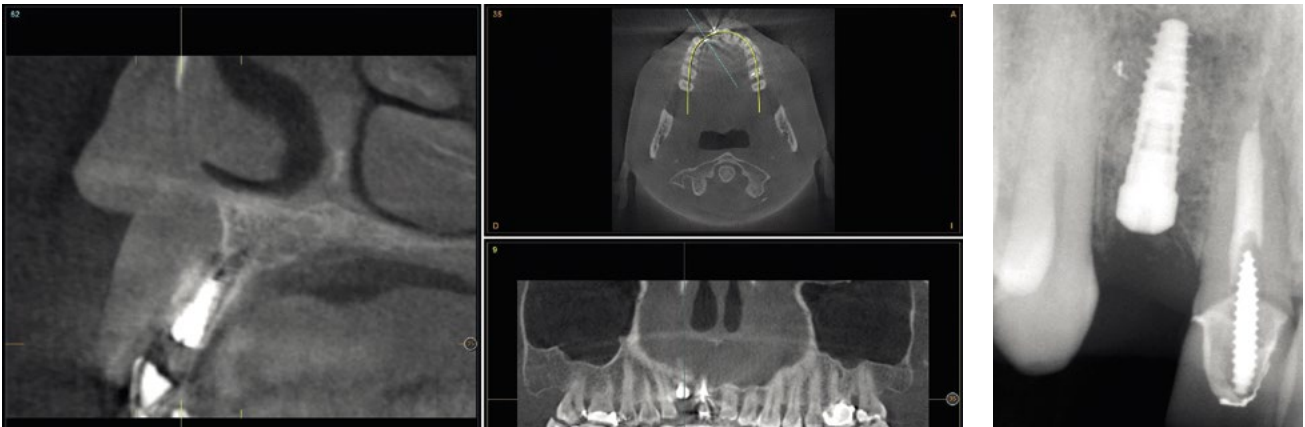
Figures 5 and 6. Diagnostic image of the implant located in position 1.2

To continue with the study of the case, a Cone Beam is performed where we can observe three-dimensionally the position of the implant located in position 1.2. In the sectional cuts it is visualized completely positioned toward vestibular with an almost complete resorption of the cortical bone of this area, which explains the underlying soft tissue problems. The periapical radiography shows the position of the implant with respect to adjacent teeth (Figures 5 and 6). With this image we proceed to create a flap and the explantation of the implant. The crown located in tooth 1.1 is also removed to be able to make another crown that will serve to support the provisional extension for zone 1.2, while the first procedure heals. In this first approach a block grafting obtained from the mandibular ramus is also placed which is fixed with a microscrew in the area to be regenerated where the vestibular cortical has been lost. Once fixed and positioned, it is filled around the block grafting with particulate bone obtained with a bone-scraper of the same donor zone embedded in PRGF-Endoret for better fixation and cellular viability (Figures 7-9).

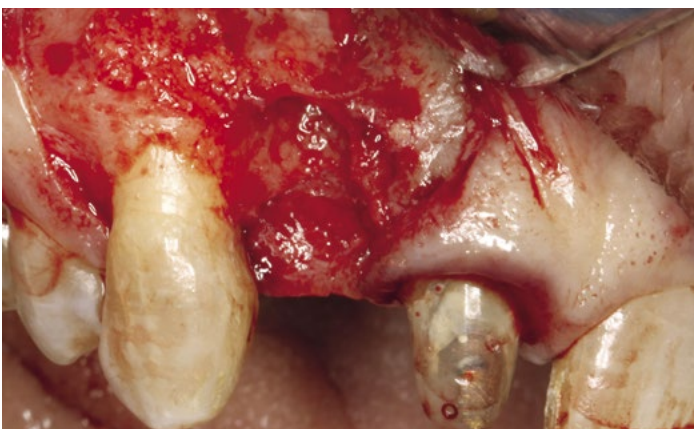
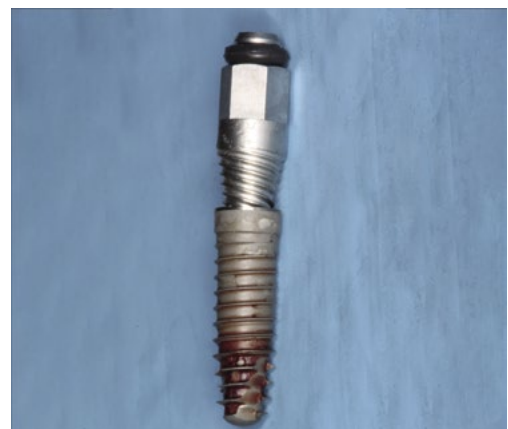
Figures 7 and 8. Explantation of the implant where the defect left by the loss of the vestibular cortical is observed.

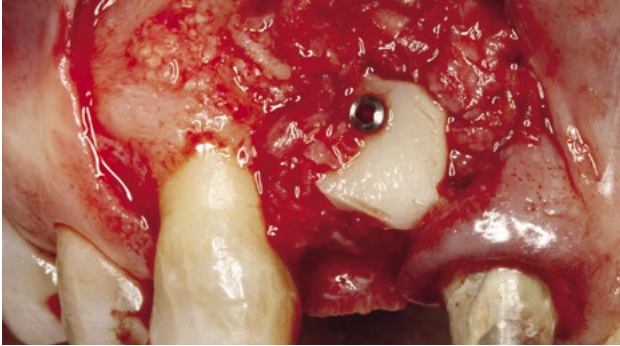
Figure 9. Image of the placement of the block and particulate graft to achieve filling the defect and obtain the 4 mm vertical growth needed for the new implant.

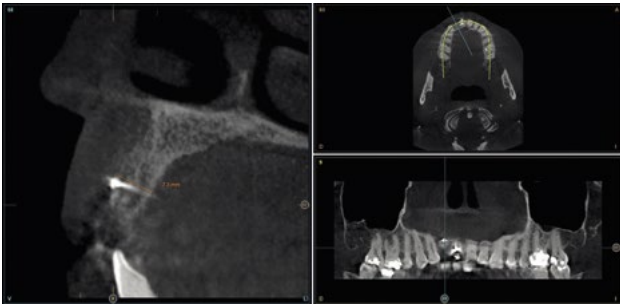
Figure 10. Cone Beam planning where a complete regeneration of the defect is observed.

Four months later, a new dental cone-beam is performed to quantify the gain obtained in width with the regenerative procedure. It is observed in the sectional cut that a crest width of more than 7 mm and a complete regeneration of the alveolar ridge has been achieved, allowing the insertion of a new dental implant in the adequate position (Figure 10). In the surgical reentry, the information of the Cone-Beam is verified with a total integration

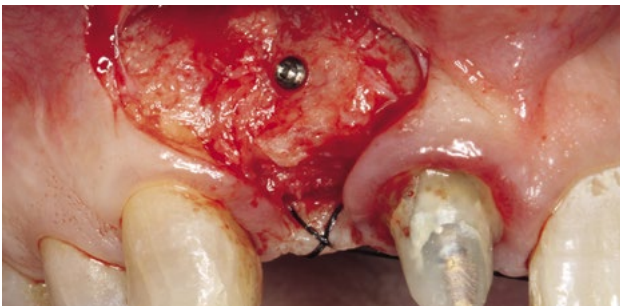
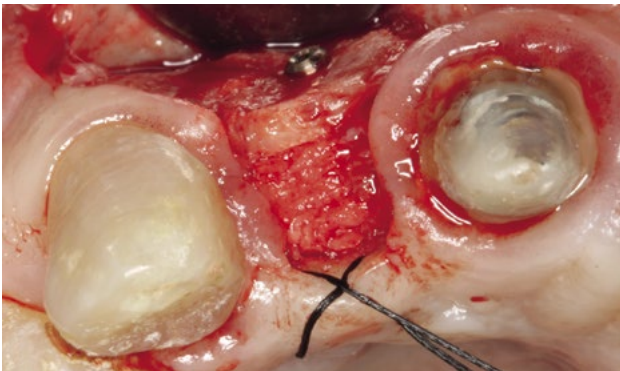
Figures 11 and 12. Clinical images of the defect regeneration. It is observed how a complete integration of the block grafting has been achieved.

of the graft material, as shown in the clinical images at the time of lifting the flap for the insertion of the implant (Figures 11 and 12). The micro-screw is removed and the implant is placed, which is performed by vestibular compression of the graft to gain in this manner even more contour in this area (Figure 13). The implant is left in a surgical phase, with a low healing abutment that allows a subsequent location of the same without an aggressive soft tissue surgery when the construction of the prosthesis is initiated. The provisional crown remains as an extension from the tooth 1.1.

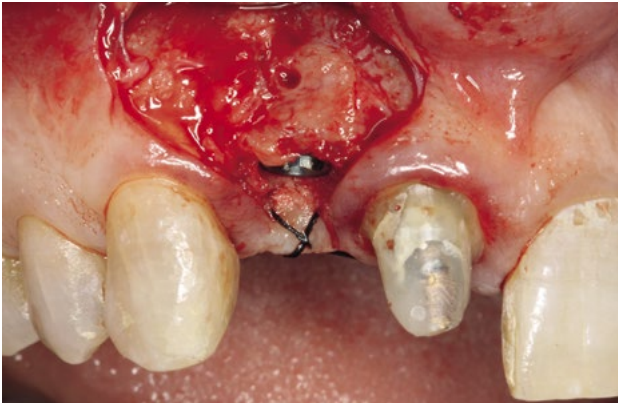
Figure 13. Juxtacrestal placement of the implant, which is used in turn as an expander moving the graft toward the vestibular area to gain a greater bone contour at this level.

In cases like the one shown, of a single implant, an additional expansion can also be generated with the implant itself to correct the present defect. The insertion of the implant with expansion gives us an extra correction that makes it gain even more volume at this level. This technique of vestibular expansion of the graft once integrated, through the preparation of the alveolus in a way that generates compression, has been described by our study group with good stable and lasting results

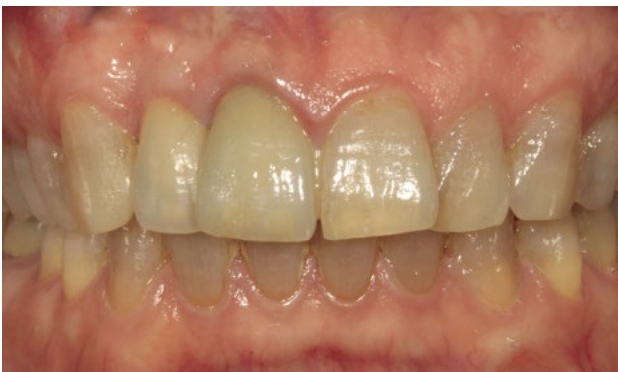
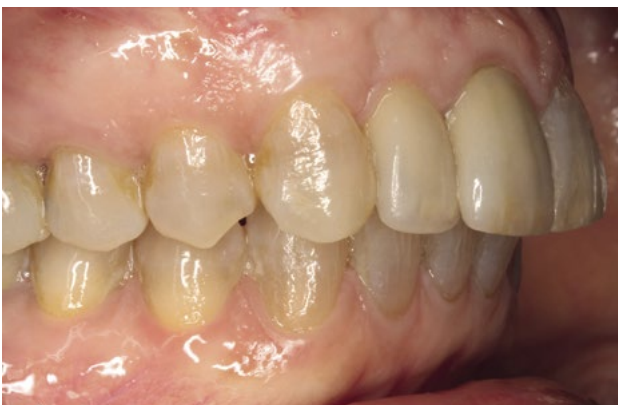
Figures 14 and 15. Rehabilitation completed with the integration of pieces 1.1 and 1.2 in the rest of the aesthetic front.

Three months later, the prosthetic phase begins. The state of the gingival tissue is correct, although at vestibular level we would like to achieve a decrease of the zenith of the future tooth, so a connective tissue graft is planned that allows this more appropriate emergence profile conformation. The case ends with E-max crowns at the level of 1.2 and 1.1, achieving a harmonious smile and fully integrated in the rest of the smile, regarding colour, emergence and disposition of the gingival margins (Figures 14-15). The patient continues a follow up for years, maintaining the stability of the performed rehabilitation (Figure 16).

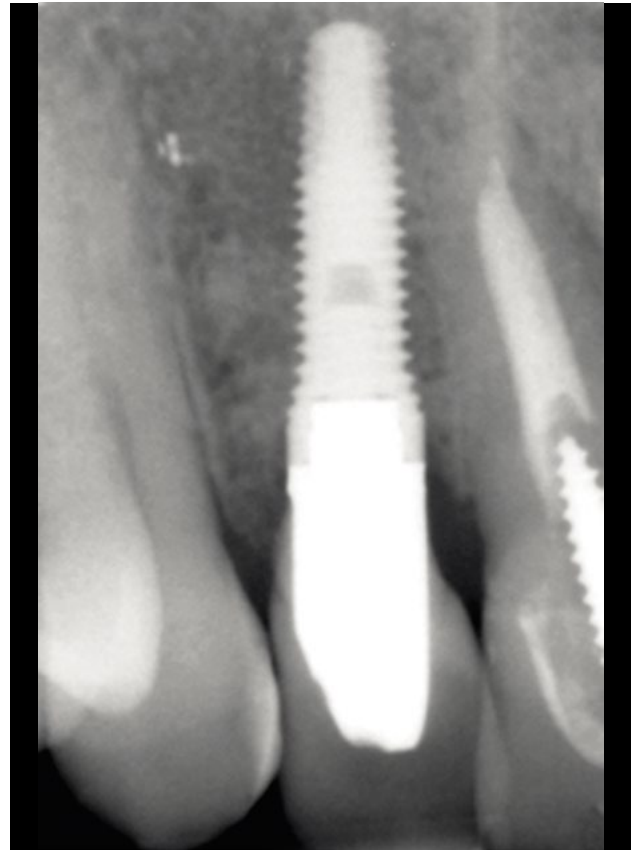
Figure 16. Follow-up radiography after 8 years, where the obtained result is maintained.
